Draft Final Remedial Investigation Report

Culebra Island Site Puerto Rico

FUDS Project No. I02PR0068

July 2014

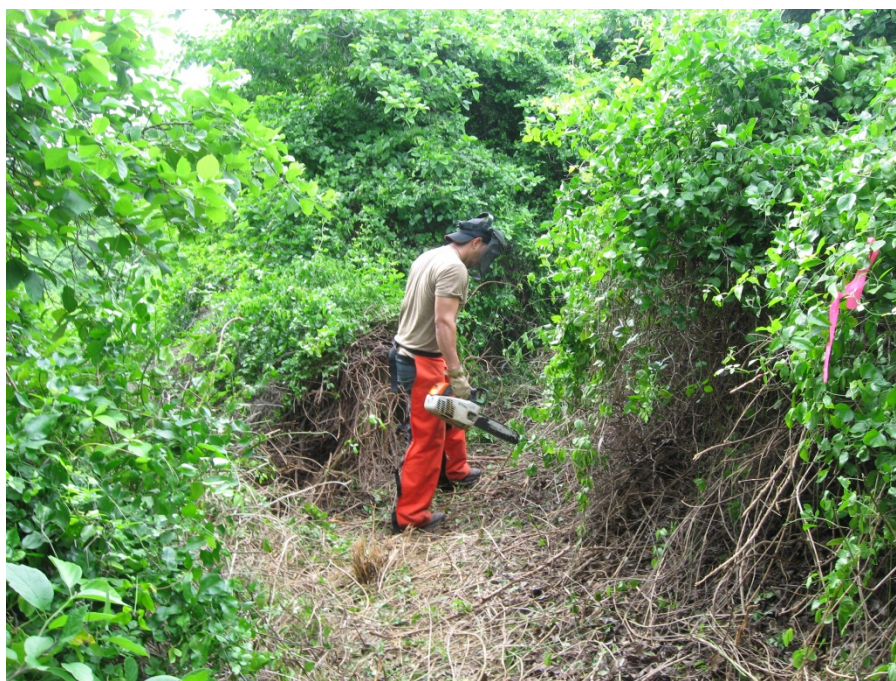
Photograph 4-1: Vegetation Removal

Vegetation removal activities were conducted in undeveloped areas to provide access for DGM surveys on transects and grids. Vegetation teams consisted of UXO qualified personnel and subcontracted deforester labor. Prior to commencing with vegetation removal activities, a local field biologist provided the vegetation removal teams with training in endangered species identification and mitigation procedures. This training was in coordination with the endangered species mitigation SOPs (Appendix M of the WP). The Team Leader utilized a Trimble Pro XRT Differential Global Positioning System (DGPS), or equivalent, to follow each transect, following a path of least resistance to help minimize devegetation and avoiding all properties where a ROE had not been obtained. Vegetation removal teams utilized handheld saws and cutters to clear the footprints needed, a path approximately 5 feet wide for transects and a 50-foot x 50-foot area for grids.

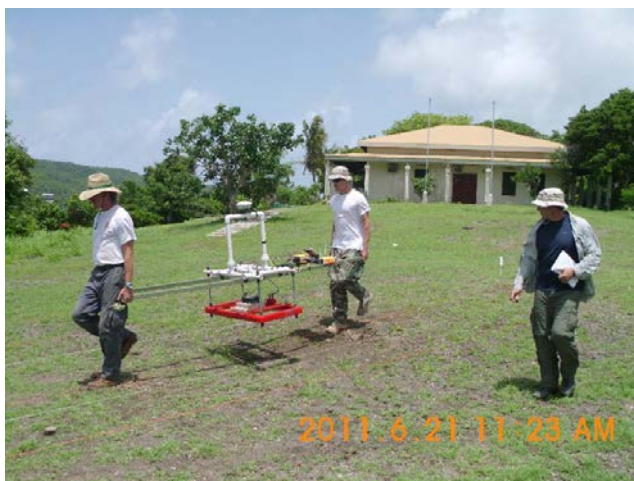
Photograph 4-2: Survey of IVS

Based on a previous agreement obtained during the TPP, a Geophysical Prove-Out would not be required and was replaced with a Geophysical System Verification (GSV) with an Instrument Verification Strip (IVS) Plan and Report. The IVS was located in the DNER property in MRS. The complete GSV report is provided in Appendix J. Further details regarding the selection of the location, test items, and procedures followed are located in the report. In lieu of a GPO, daily analog and digital instrument response tests were performed each morning and afternoon over the IVS. A combination of small Industry Standard Objects (ISOs), intended to simulate 37mm projectiles, and large ISOs, intended to simulate 105mm projectiles or 4.2 inch mortars, were used in each IVS. The response curves for these ISOs are well documented for both the best case orientation (vertical) and the worst case orientation (horizontal). Four of each ISO were used: two horizontal at depths 3 and 7 times ISO diameter, and two vertical at the same 3 and 7 times diameter depth. EM61-MK2 responses for each seed item were compared to published response curves and daily repeatability to ensure the equipment performed as designed.

The test strip results and anomaly selection criteria were provided to the USACE Geophysicist prior to starting fieldwork. Any recommended changes to the anomaly selection criteria were discussed with USACE's Geophysicist prior to implementing. USA documented the GSV results in a Draft and Final Geophysical System Verification letter report (the Final GSV Report is provided in Appendix J) that documented IVS setup, digital geophysical detection results, grid line spacing test results, initial grid anomaly selection criteria, and recommended final DGM performance metrics. The test strip was installed in a designated area at the USFWS facility located on Culebra.

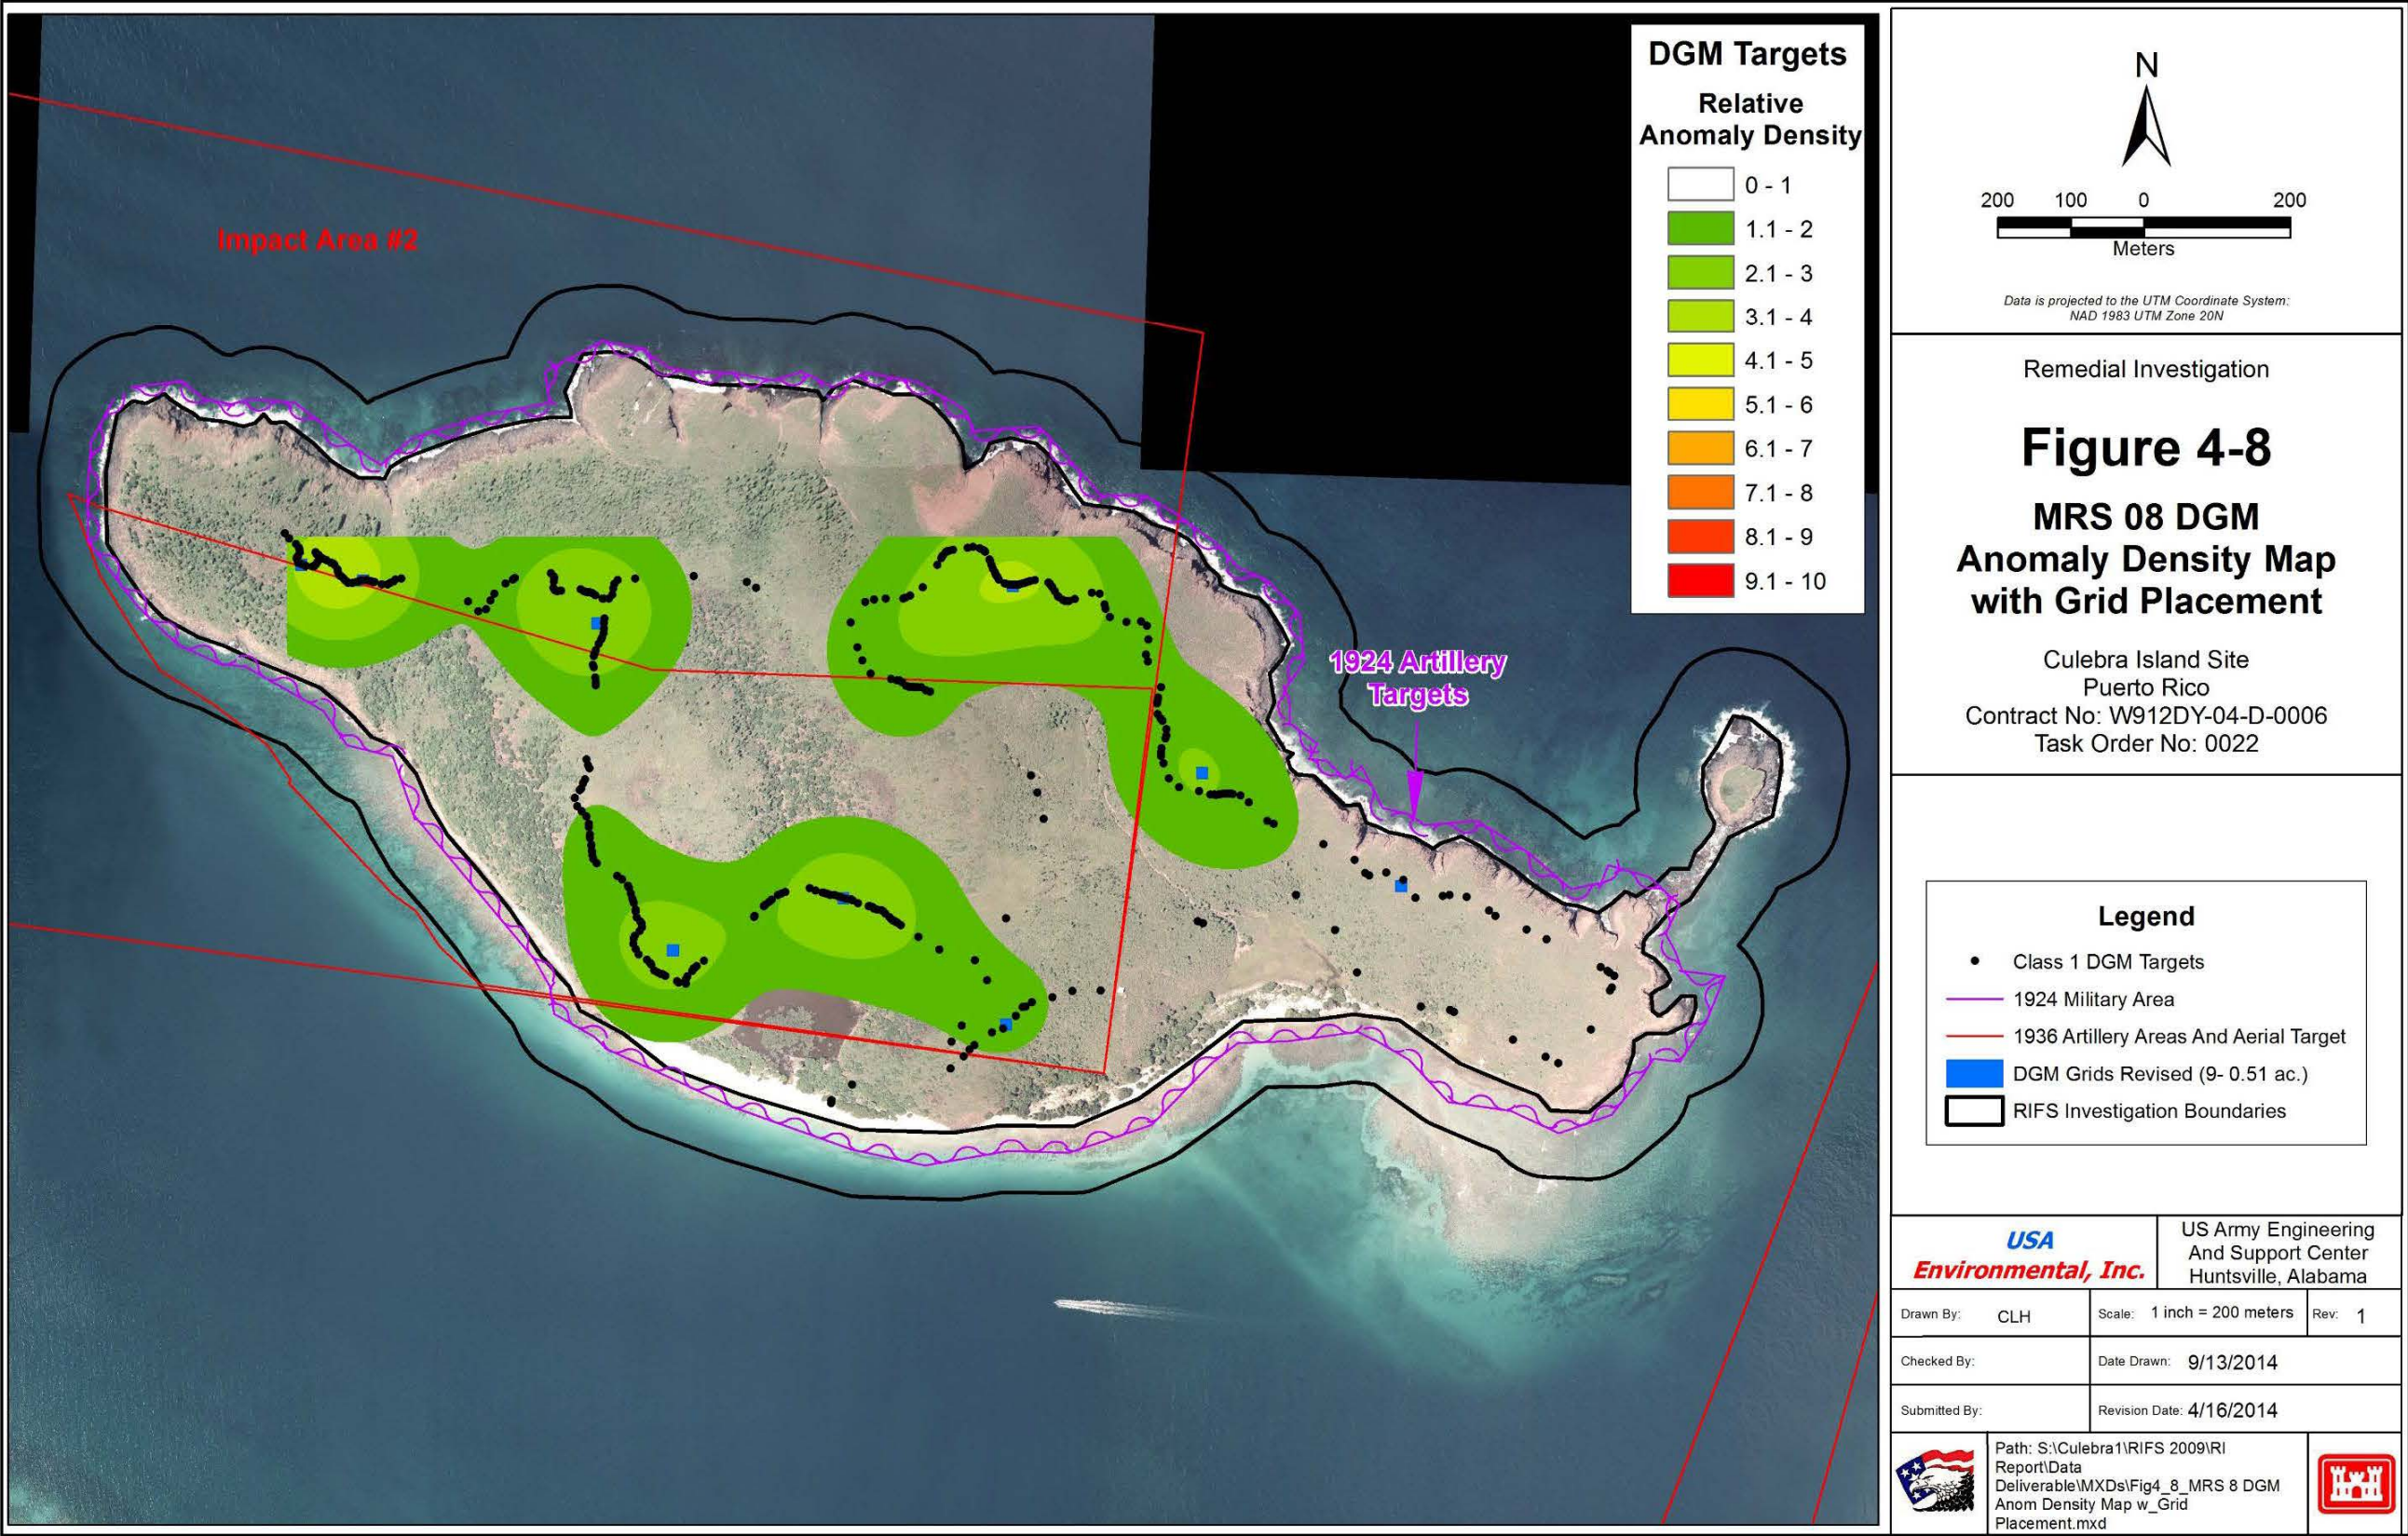
Figure 4-8: MRS 08 DGM Anomaly Density Map with Grid Placement

550 The anomaly density on MRS 08 is relatively low; however, there are sufficient amounts of MD
551 to confirm the western side of MRS 08 was used as 75 mm artillery target area (from MRS 06
552 firing points), even if for a short period of time. No MEC or MD items were recovered along the
553 beach areas of MRS 08. The presence of MD in the upland areas indicates the possibility for an
554 explosive hazard to be present in MRS 08.

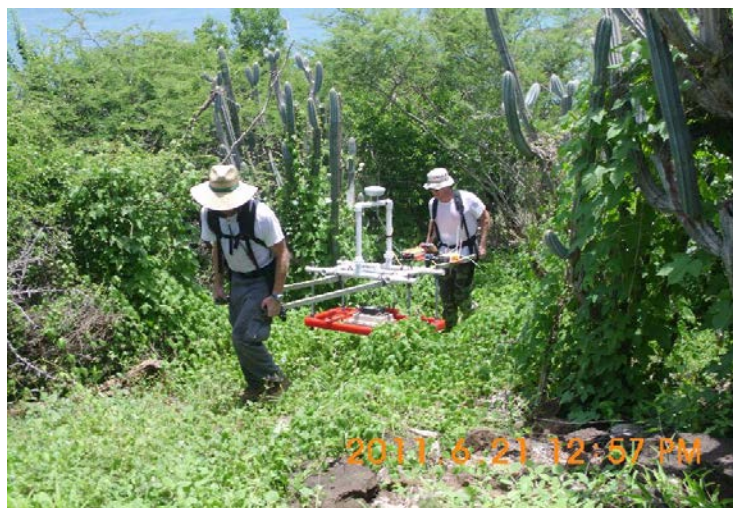
Photograph 4-3: DGM Transect Survey

Grid locations were selected with one grid near the center or peak of the high density areas to provide information for removal action cost estimates. Other grids overlapping the edges of the high density area were used to better document the MEC extent at each high density area. DGM grid (corner) locations were staked out using the Pro XRT with the external antenna mounted to a telescoping range pole, capable of extending 25 ft. Each grid area was surveyed by the field biologist to avoid all critical habitat and endangered species. Once a grid was established and accepted by the field biologist, it was devegetated in the same manner as transects, with the edges of each grid extended approximately 5 ft to allow the DGM sensor/operators to safely turn around. The cleared grid would then be seeded with a dynamic repeatability item (small ISO buried 3 to 7 times its diameter), and surveyed with the EM61-MK2, positioned with the Pro XRT, or traditional line, station, fiducials, if DGPS proved to be inadequate. Grid survey line spacing, necessary to reliably detect objects as small as a 37mm projectile were located every 2.5 ft. Grid coverage was 95% or greater at the 2.5 ft line spacing. All unavoidable obstacles in any grid were located with the Pro XRT and documented in the DGM maps. Grid anomalies were selected, as approved in the final GSV Report. DGM grid mapping resulted in 3,339 DGM anomalies. A total of 1,229 anomalies were selected for intrusive investigation between all six MRSs (Appendix J).

Dig lists and target maps for each DGM grid were provided to the USACE Geophysicist for review and approval. A recommended dig list of anomalies to intrusively investigate was created for each MRS. A decision was made by field teams to utilize the Whites DFX 300 All Metals Instrument in place of the EM61-MK2 as required by the approved WP. This decision was based on the re-growth of native vegetation along transects that had taken place to the degree it was compromising the team's ability to safely transport the EM61 equipment (stretcher-mode) into the grids. Because the DFX 300 instruments were smaller, it was easier to navigate within the excessive re-growth. This was not initially approved by USACE resulting in a corrective action (included in Appendix F); however, the overall intent was to remove the anomaly (not reach an acceptable mV reading) and the DFX 300 instruments were able to locate the anomalies without issue. All anomalies identified were flagged, excavated and removed. The investigation was not adversely impacted.

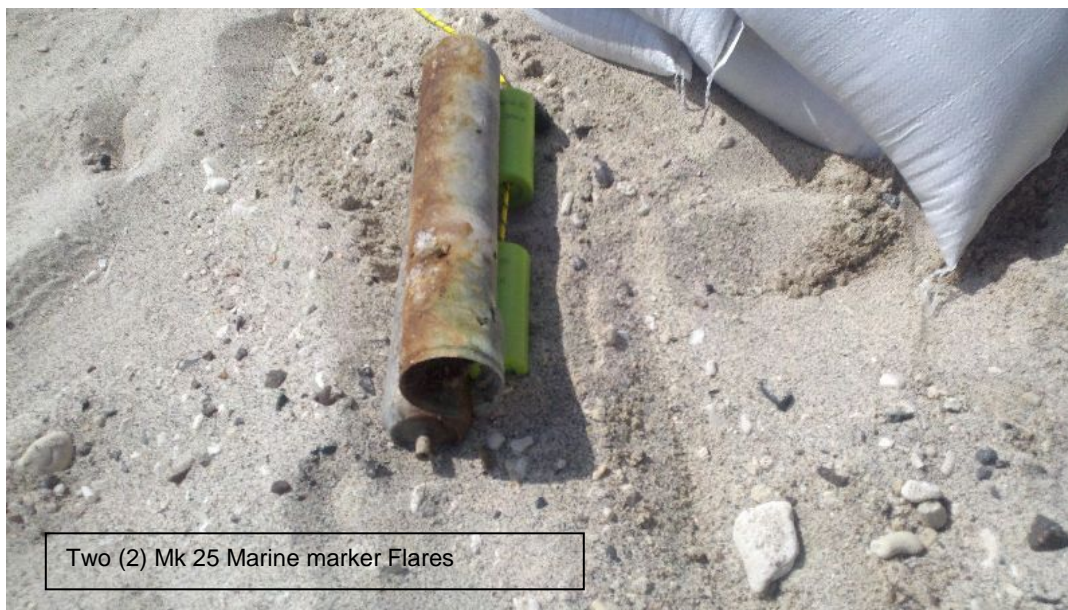
Photograph 4-5: Disposal of MEC Items in MRS 09

Date	Location	Shot Time	Time Cleared	Munitions Destroyed
26 May 2011	MRS 09	15:30 local	16:00 local	(2) Mk 25 Marine Markers
13 June 2011	MRS 09	10:30 local	11:00 local	(1) partial BDU-33

All MD recovered from investigation and after demolition was inspected by the SUXOS, re-inspected by the UXOQCS, certified as MDAS, and documented on Form 1348 found in Appendix A. The MDAS was drummed, sealed and locked in secure storage until it was shipped offsite to TES for disposal, in a form where it could only be identified by its basic content. TES issued a Certificate of Destruction (COD), a copy of which has been provided in Appendix A.

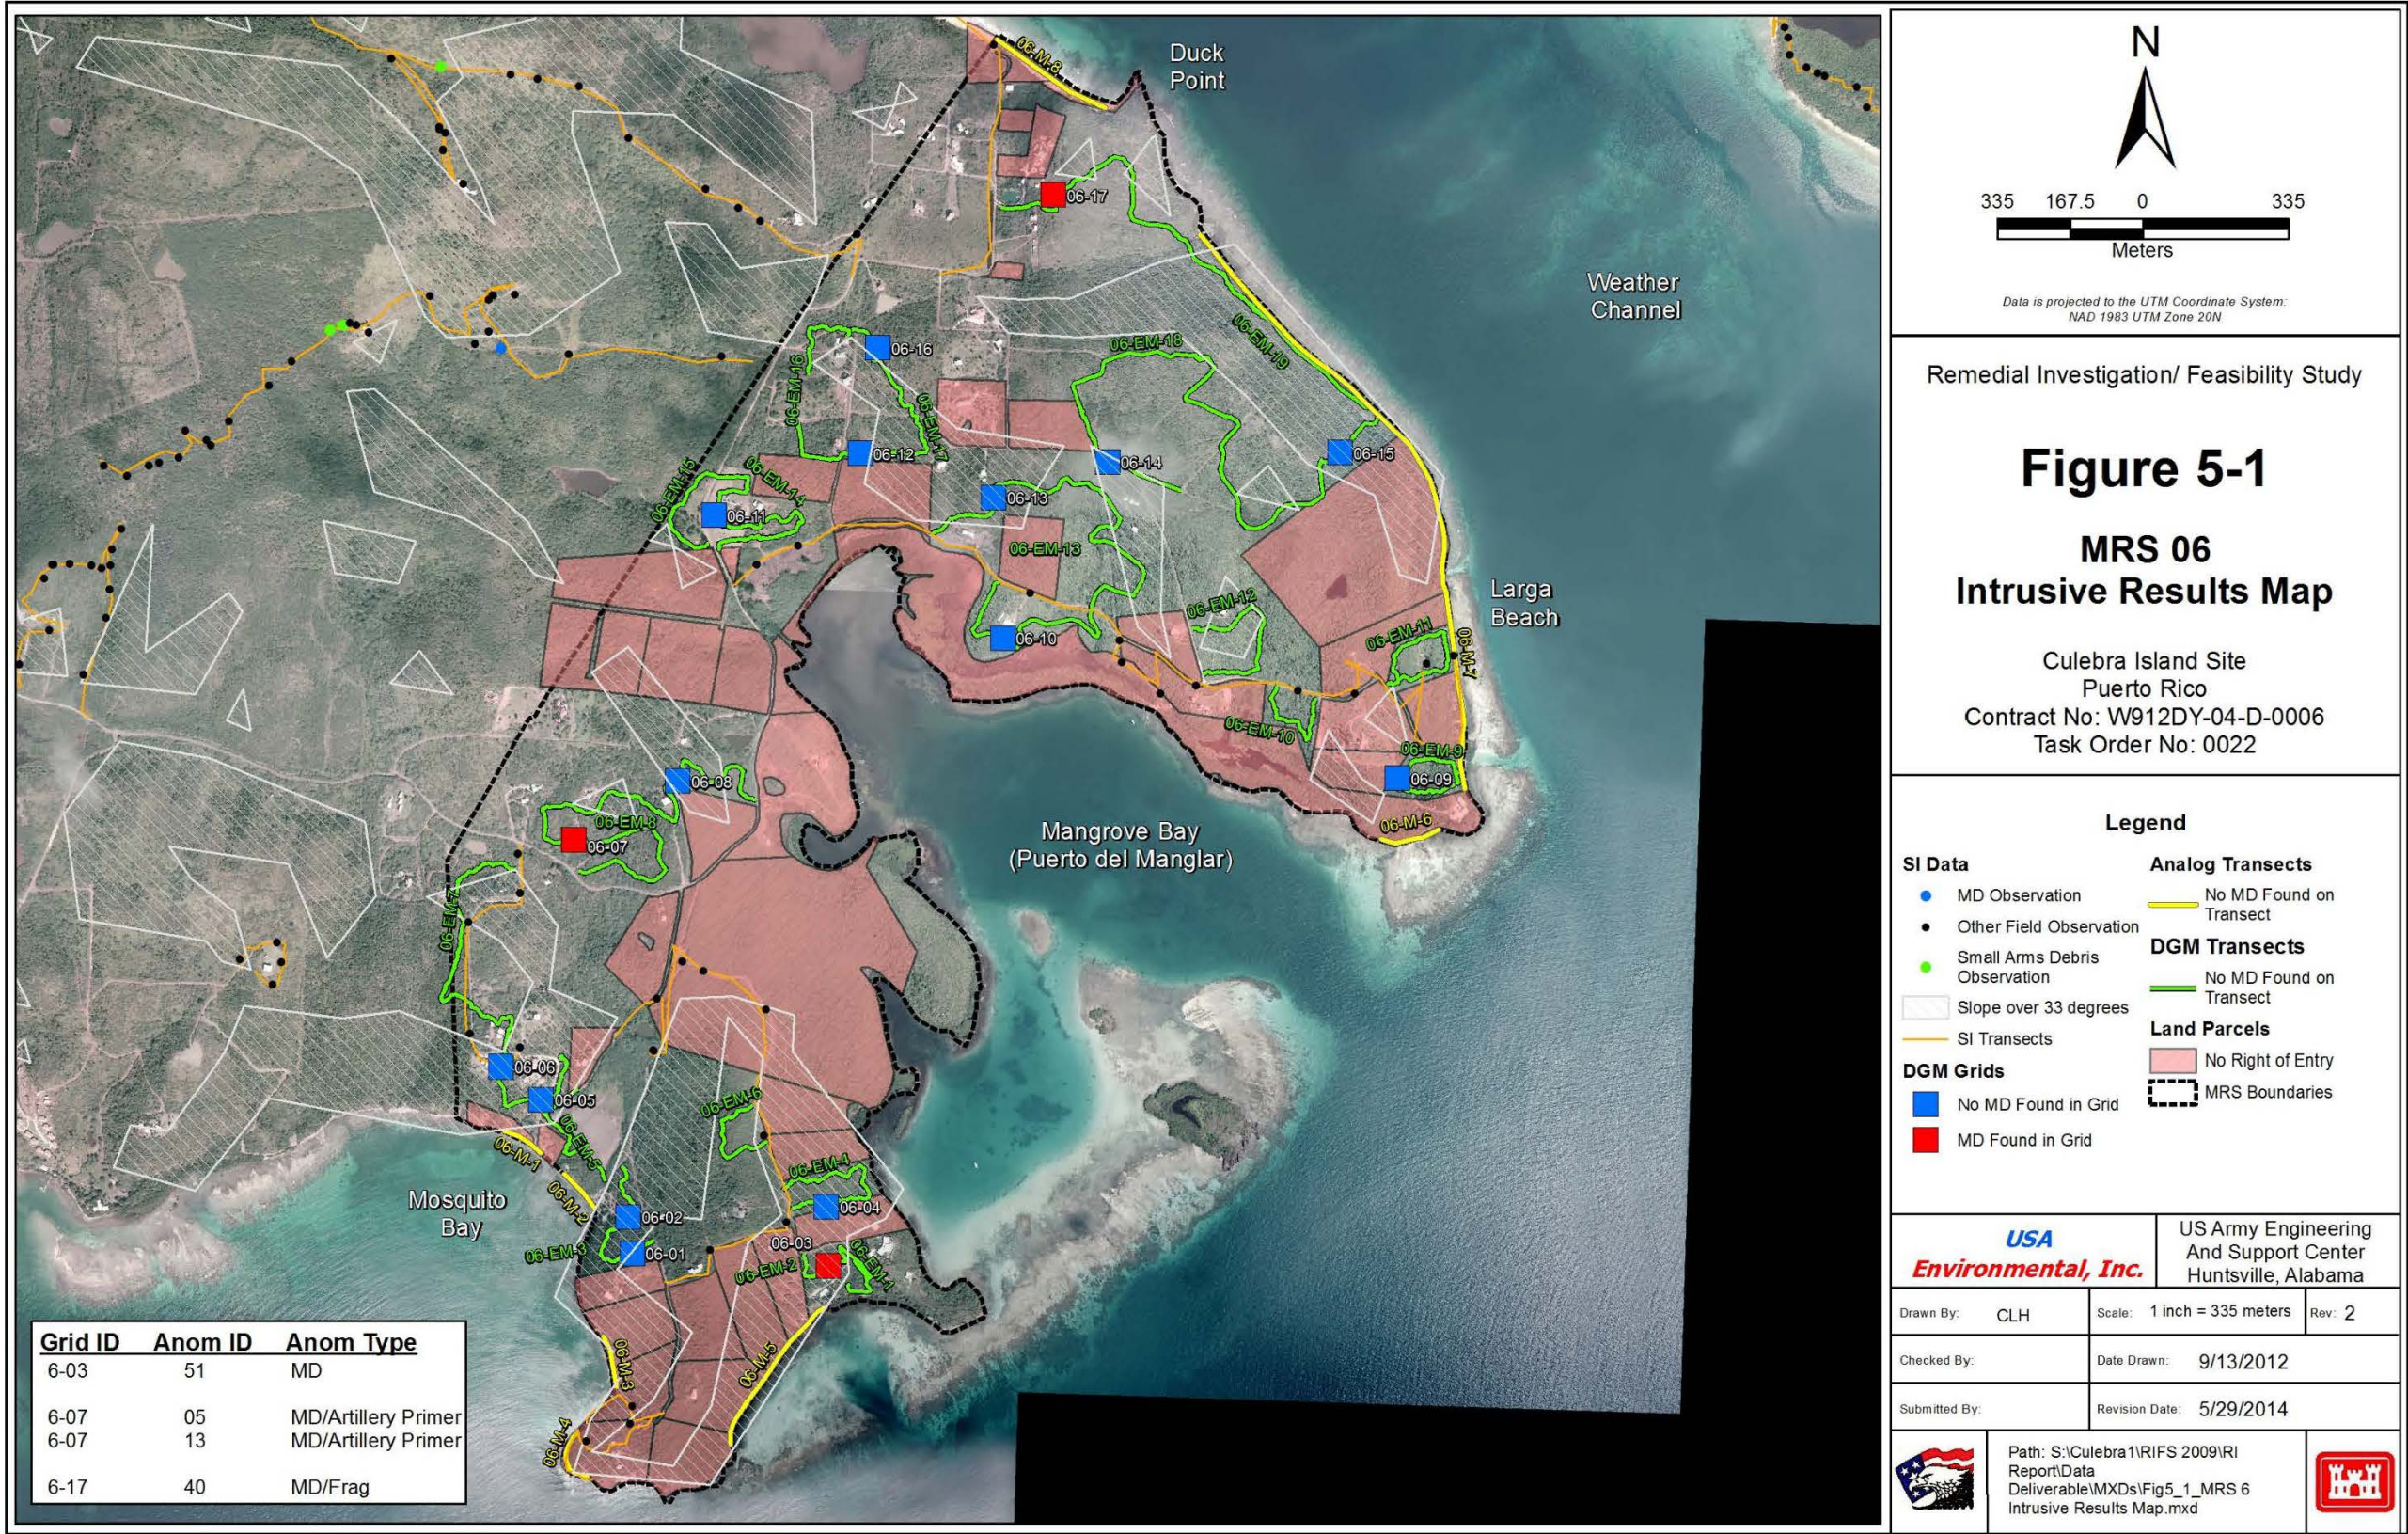
Figure 5-1: MRS 06 Intrusive Results Map

Characterization was additionally impacted by unsafe slopes. Steep slopes were encountered throughout the MRSs. A generalized depiction of the slopes over 33 degrees is represented on Figures 5-1 through 5-6. In the areas that could be traversed the investigation proceeded, but when safety was a factor the slopes were avoided.
